# PLAY AREA SAFETY INSPECTION REPORT

Bubbenhall Parish Council

24 September 2015

Site Owner : **Bubbenhall Parish Council**  
Site Name : Bubbenhall Parish Council - Playing Field By Village Hall  
Date of Inspection : 24 September 2015  
Inspected by : Bill Slater

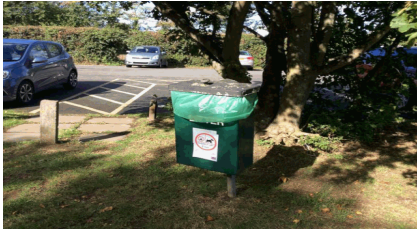
| Facilities | | | | |
|---|---|---|--|--|
| Dog Waste Bins<br><br>Risk Score : 3<br>Risk Level : Very Low | Bins | Satisfactory<br><br> | | |

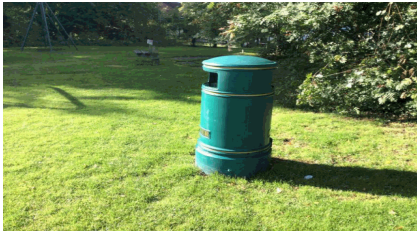
| Facilities | | | | |
|---|---|---|--|--|
| Litter Bins<br><br>Risk Score : 3<br>Risk Level : Very Low | Bins | Satisfactory<br><br> | | |

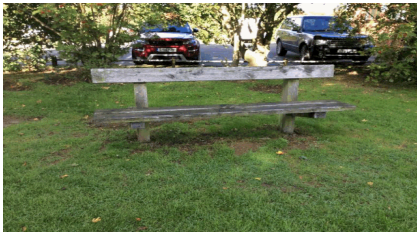
| Facilities | | | | |
|---|---|---|--|--|
| Seating - Benches - Timber<br><br>Risk Score : 3<br>Risk Level : Very Low | Seating | Satisfactory<br><br> | | |

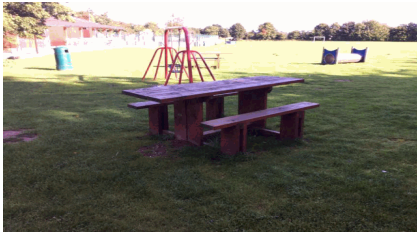
| Facilities | | | | |
|---|---|---|--|--|
| Seating - Picnic Tables<br><br>Risk Score : 3<br>Risk Level : Very Low | Seating | Satisfactory<br><br> | | |

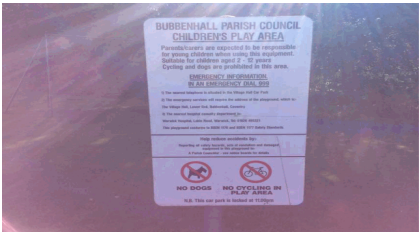
| <b>Sign - Info</b><br><br>Risk Score : 2<br>Risk Level : Very Low | <b>Signage</b> | <b>Satisfactory</b> | | | |

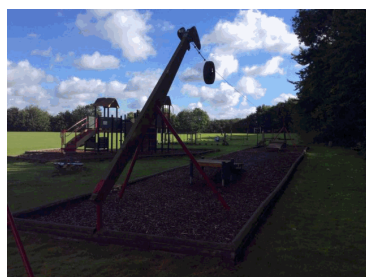
## Cableway

Risk Level : Low

Risk Score : 5

| Recommended Maintenance and Risk Assessment Evaluation | | Risk Level | Risk Score ‡ |
|---|---|---|---|
| Finding : | Chain covers prevent a through inspection of all chain links | Low | 5 |

| Recommended Maintenance and Risk Assessment Evaluation | | Risk Level | Risk Score ‡ |
|---|---|---|---|
| Task : | Remove chain covers to inspect according to manufacturer's instructions. | | |

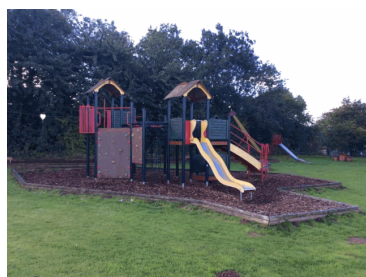
## Multiplay - With Slide

| Comments, action or control required | | Risk Level | Risk Score ‡ |
|---|---|---|---|
| Finding : | Item - Damaged | Low | 5 |
| Notes : | Rubber button damaged - monitor. | | |
| Finding : | Chain covers prevent a through inspection of all chain links | Low | 5 |
| Finding : | Laminate damaged | Low | 7 |
| Notes : | Roof panels. | | |

| Comments, action or control required | | Risk Level | Risk Score ‡ |
|---|---|---|---|
| Task : | Remove chain covers to inspect according to manufacturer's instructions. | | |
| Task : | Rub down and treat damaged edges | | |

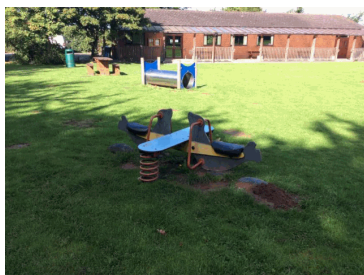
## Rocker - Seals 2 Seat

| Recommended Maintenance and Risk Assessment Evaluation: | | Risk Level | Risk Score ‡ |
|---|---|---|---|
| Finding : | Worn ground areas | Low | 6 |

| Recommended Maintenance and Risk Assessment Evaluation: | | Risk Level | Risk Score ‡ |
|---|---|---|---|
| Task : | Make good | | |

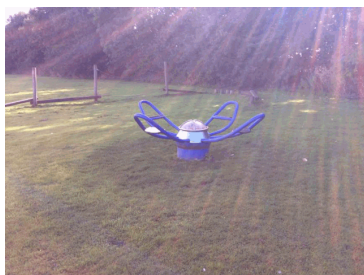
## Rocker / Rotator

| Comments, action or control required | | Risk Level | Risk Score ‡ |
|---|---|---|---|
| <b>Equipment</b> | No remedial maintenance work is required at this time. | | |
| <b>Surfacing - Grass</b> | No remedial maintenance work is required at this time. | | |

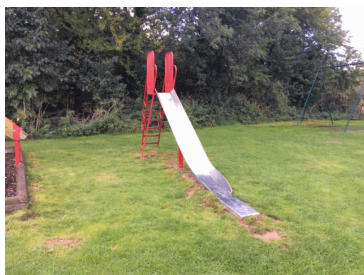
## Slide

The item fails to meet the requirement of the relevant standard.

| Comments, action or control required | | Risk Level | Risk Score ‡ |
|---|---|---|---|
| Finding : | Entrapment - Head & Neck | Low | 5 |
| Finding : | Access fails entrapment requirements | Low | 5 |

| Comments, action or control required | | Risk Level | Risk Score ‡ |
|---|---|---|---|
| Task : | No action required, based on risk assessment, as asset pre-dates BSEN1176 | | |
| Task : | Monitor and check on a routine basis | | |

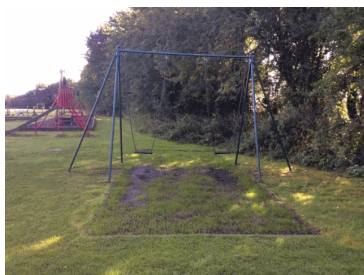
## Swing - Junior - 1 Bay 2 Seat

The item fails to meet the requirement of the relevant standard.

| Comments, action or control required | | Risk Level | Risk Score ‡ |
|---|---|---|---|
| Finding : | The distance between the seat side and the support is insufficient | Low | 5 |

| Comments, action or control required | | Risk Level | Risk Score ‡ |
|---|---|---|---|
| Task : | Monitor and check on a routine basis | | |

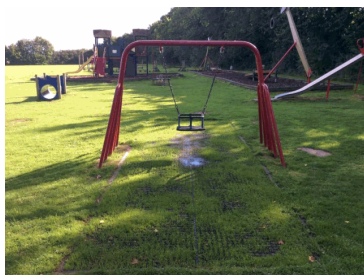
## Swing - Toddler - 1 Bay 1 Seat

| Comments, action or control required | | Risk Level | Risk Score ‡ |
|---|---|---|---|
| Finding : | Some chain wear | Medium | 8 |

| Comments, action or control required | | Risk Level | Risk Score ‡ |
|---|---|---|---|
| Task : | Monitor for further deterioration and replace at 40% wear | | |

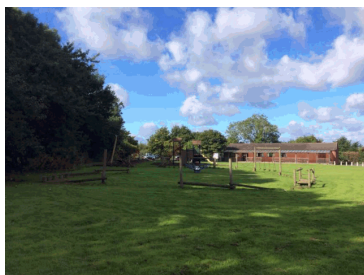
## Trim Trail x 12

| Comments, action or control required | | Risk Level | Risk Score ± |
|---|---|---|---|
| Finding : | There are natural splits/shakes in the timbers. | Medium | 8 |
| Finding : | Fails grasp requirements | | |

| Comments, action or control required | | Risk Level | Risk Score ± |
|---|---|---|---|
| Task : | Shakes vary. Monitor and consult manufacturer is dimensions exceed 8mm at sections used to grip/grasp. | Low | 4 |
| Task : | Monitor and check on a routine basis | | |

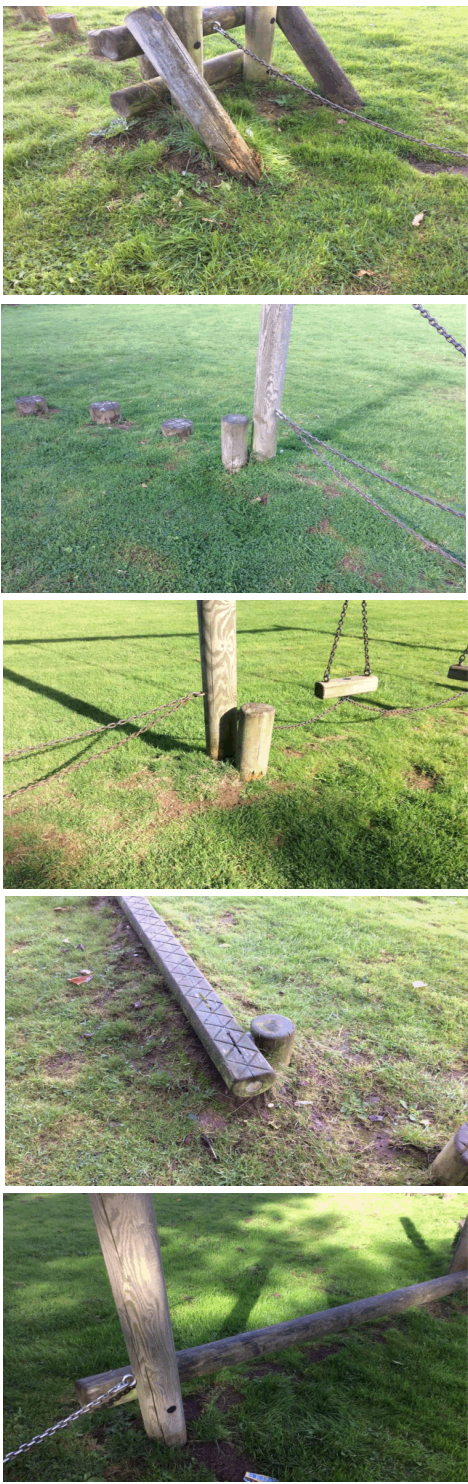
| <p>Finding : There is decay to timber components which may affect structural integrity</p> <p>Finding Date : 24/09/2015</p> <p>Notes : Throughout.</p> <div data-bbox="628 353 1098 1832"> </div> <p>Task : Replace decayed components where possible, and plan replacement of item.<br/>Check on a routine basis, especially at ground or foundation level</p> | Medium | 9 |

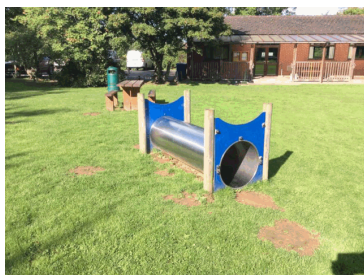
## Tunnel - Crawl

| Comments, action or control required | | Risk Level | Risk Score ‡ |
|---|---|---|---|
| <b>Equipment</b> | No remedial maintenance work is required at this time. | | |
| <b>Surfacing - Grass</b> | No remedial maintenance work is required at this time. | | |
